PHASE II ARCHAEOLOGICAL SURVEY OF THE FORT HAYS MUNICIPAL GOLF COURSE

The City of Hays, Kansas

**Burns & McDonnell Engineering Company, Inc.
Engineers-Architects-Consultants
Kansas City, Missouri**

June, 2005

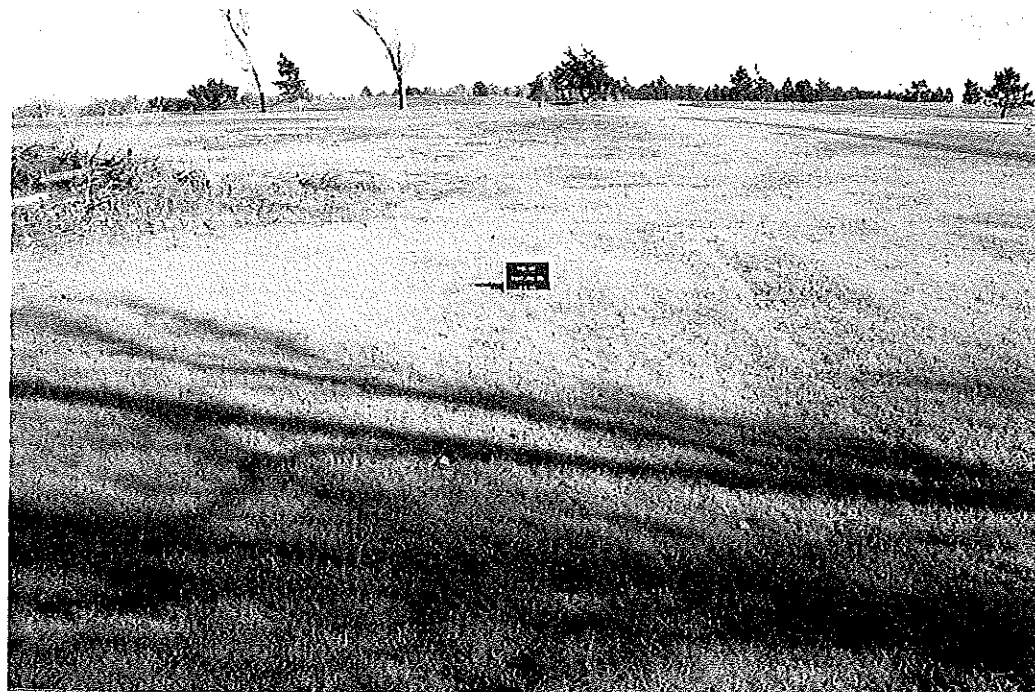
BMF58 was a foundation identified by the observation of a rectangular footing depression (Figure A-1; Photograph 5-1). The GPS mapping of this feature, places it directly on a structure plotted on the 1966 and 1983 photo revised Hays South 7.5" quadrangle map (Figure A-2). Photographs taken in 1966 show this area was where a modern structure related to the golf course was located (Photograph 5-2). The clubhouse was located at the blockhouse, and is not considered as part of the NRHP site.

Photograph 5-1. BMF 58, Rectangular Outline of
Removed Golf Course Structure

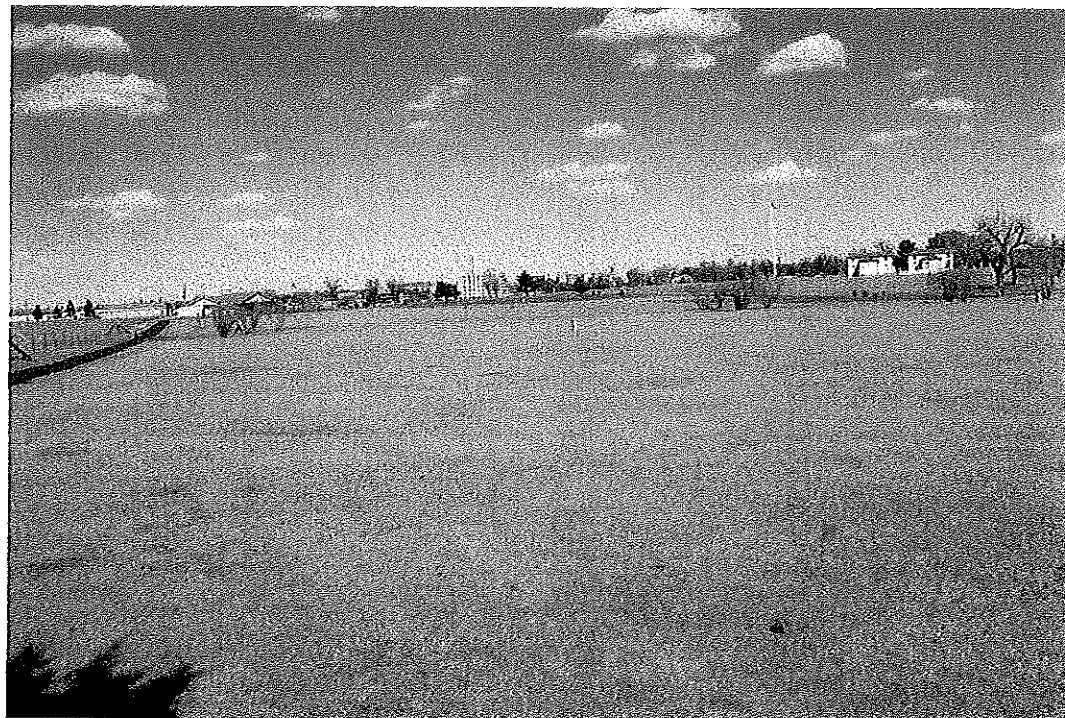
Two concentrations of rifle pit features were identified during the investigation (Photograph 5-3 and Figure 5-1). The first cluster of rifle pits (BMF2-3, 5-21, 24-25) was found along the western edge of the golf course, essentially along and within the first fairway (Figure A-1). The second cluster of rifle pit features (BMF72-74) is at the eastern end of the golf course, east of the ovens and the icehouse. These western features ranged in size from 5.2 to 11 ft. wide by 6 to 16.8 ft. long, whereas the eastern features were 7.3 to 9.2 ft. wide by 8 to 10 ft. long (Table 5-2). All of the pits within the fairways were three to five inches deep, while those outside the fairways are one to two inches deeper. The pits in the western cluster were generally rectangular in shape, while those in the eastern cluster were more square. Both sets were generally oriented parallel to roads; the Fort Dodge Road on the west side of the fort and another road (BMF75) on the east side of the fort. Many of these features were similar in construction, with a back dirt pile immediately adjacent to one side. The depth of the depressions and the prominence of the back dirt piles have likely been reduced because of years of compressing the ground with heavy rollers to maintain a level fairway.

Photograph 5-2. 1966 Aerial View of the Golf Course Buildings
 South of Block House, Area of Feature 58 (Courtesy of the KSHS)
 Photograph 5-3. Overview of 1st Fairway and Rifle Pits,
 Looking North

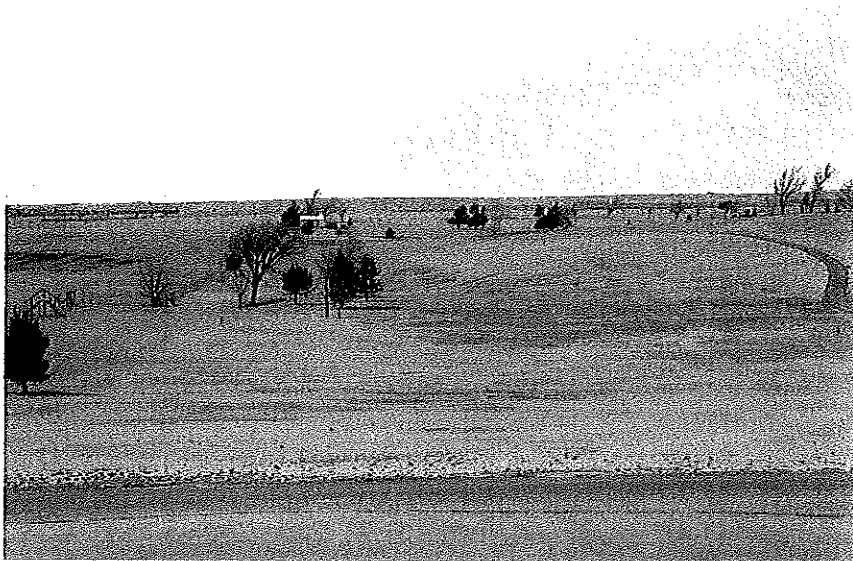
5-4

**Photograph 5-4. Overview of the 4th Fairway
and Dugout Complex, Looking West**
Photograph 5-5. Dugout Cluster 1

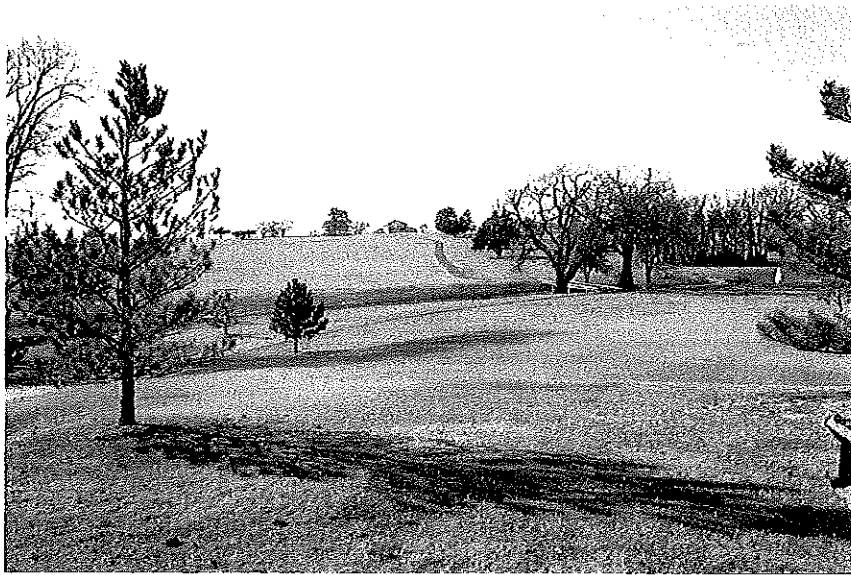
The second cluster of dugout depressions (BMF81-83, 85, 87-88, and 98) was in the seventh fairway, along the west or left bank of the stream channel (Figure 5-3; Photographs 5-6 and 5-7). As with the first cluster, these seven dugout depressions were dug into the cutbank and were closely tied to the extensive old road network observed at the site.

**Photograph 5-6. Overview of the 7th Fairway
and Cluster 2 Dugouts, Looking West**
**Photograph 5-7. Closeup View of Dugout Cluster 2,
Looking South**

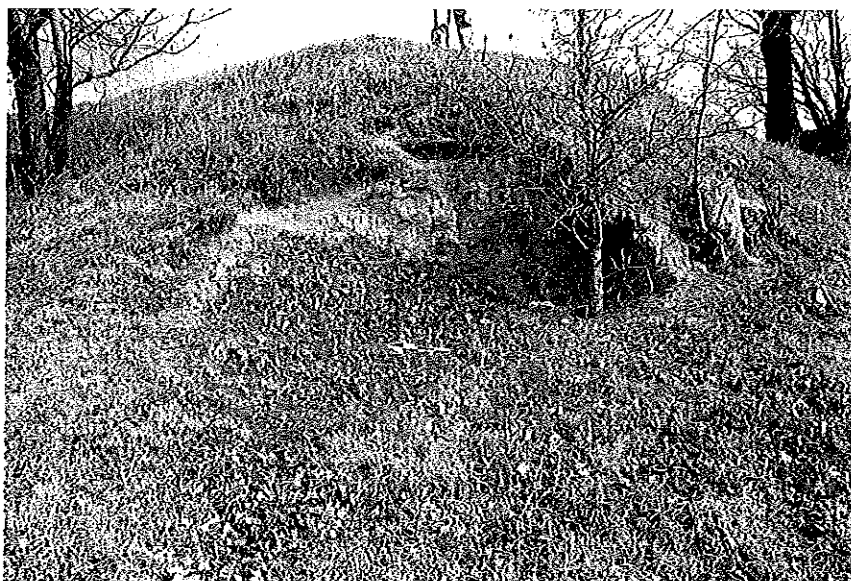
5-8

Both ovens appear in poor condition, but the southern oven (BMF66) is more complete, and was identified by the exposed heat altered limestone (Photograph 5-8), which does not naturally outcrop within this landform. The northern oven has eroded more and there was no visible thermally altered limestone (Photograph 5-9). No artifacts were observed in the eroded debris of these features, but a few shards of glass were observed just to the southwest of BMF66 (between BMF66 and the trail BMF71). It is possible that these ovens were related to the occupation of the dugout camp located to the west, just across the stream channel from the ovens.

Photograph 5-8. Feature 66 Oven, Looking East
Photograph 5-9. Feature 65 Oven, Looking East

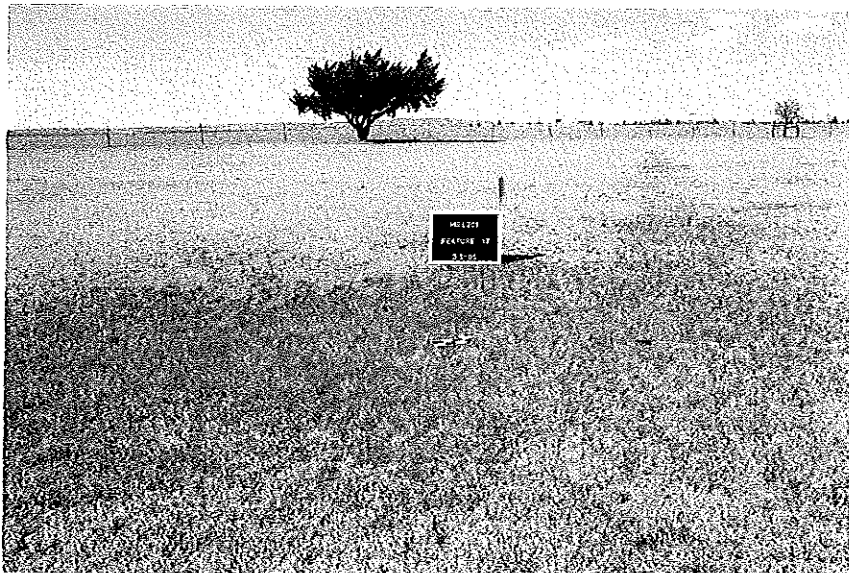
5-10

Photograph 5-10. Foot Path F22

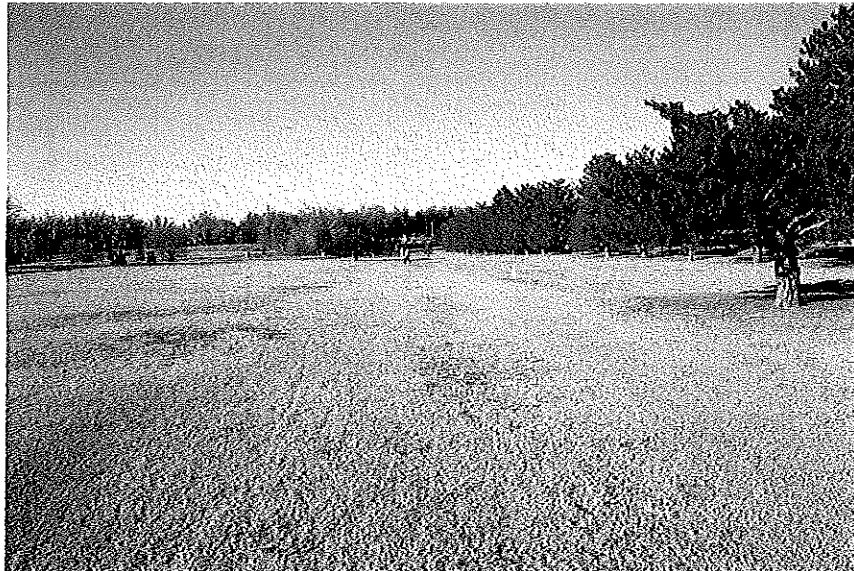
The second most prominent road, BMF75, was found on the eastern edge of the golf course (Figure A-1). This road includes at least three wagon swales running north-south, just east of Kansas Highway 274 (Photograph 5-14).

Photograph 5-14. Wagon Swales on East Edge of Site
F75, Looking North

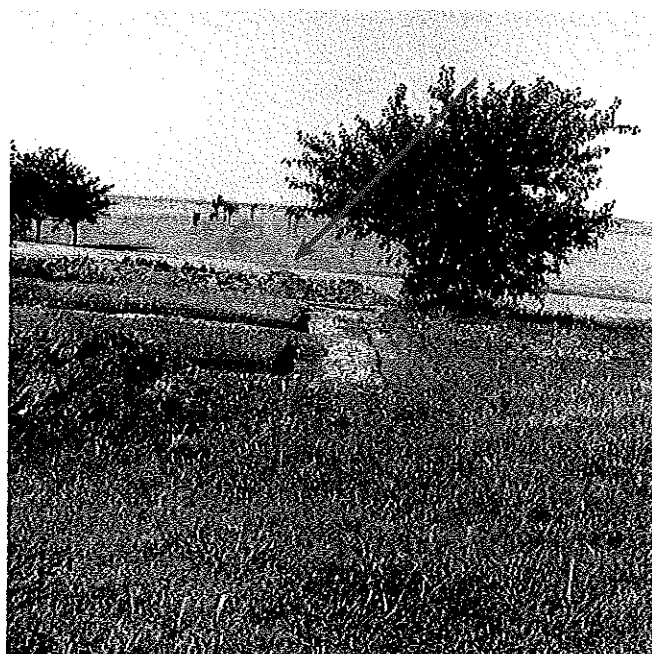
**Photograph 5-15. Completed Coal House Excavation (7/30/1970),
View of the West Wall, Looking South**

Note Road Swale in Background (Feature 26) (Courtesy of the KSHS)

Excavation photographs of the numerous features excavated by the KSHS at the site show several of the roads/trails in the background. Photographs of the completed excavation of the Coal House in 1970, shows the swale of BMF26, the road/trail from the south that leads to the guardhouse (Figure A-1, Photograph 5-15). The western view of this excavation shows the newly established golf course clubhouse and other structures and parking (Photograph 5-16), a contribution in chronicling some of the modern land use changes.

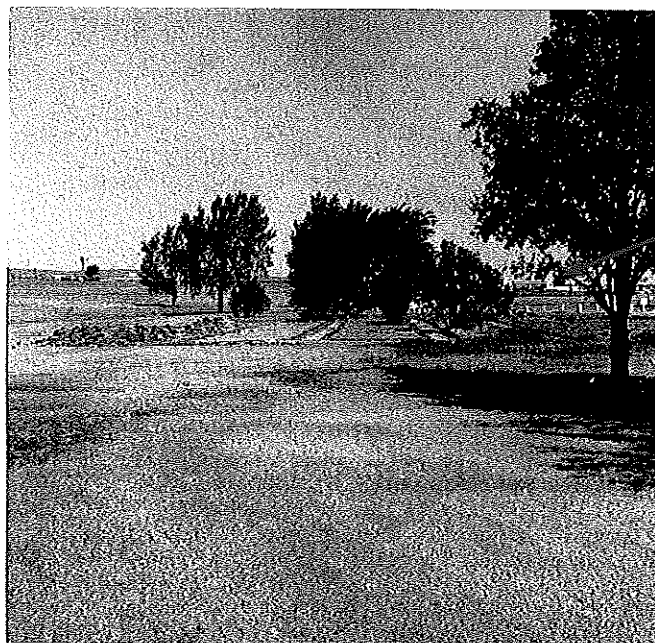
Photograph 5-16. 1970 Overview of the Coal House, Facing West
Showing newly established golf course Clubhouse (Courtesy of the KSHS)

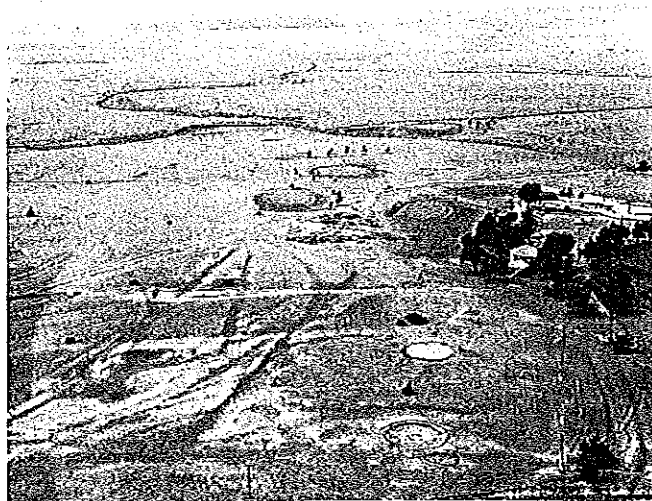
**Photograph 5-17. Broad Aerial View of the 1966 Excavation
of the Sutler's Store, Looking South**
Showing network of old roads, location of Store, and Laundress Quarters
(Courtesy of the KSHS, 7/25/1966)

The 1966 aerial photographs of the completed sutler's store excavation show some of the network of roads that can be observed today along the eastern end of the fort proper and the golf course (Photographs 5-17, 5-18, and 5-19). Within these views are BMF27, 52, and 77-80 (Figure A-1). The aerial photograph shows that the network is entwined and more complex than was viewed during the current investigation. Truly, aerial photographs can be important instruments when investigating surface sites.

Twenty-six of the features were pit depressions. Most of these small features were clustered in two areas. The first cluster, totaling 16 pits, was just east of and associated with the laundress quarters (Figure A-1). The cluster was identified on the 8th fairway, on the slope, just off the crest of the ridge. The privies are plotted on the historic maps (Figures 3-1 to 3-10) in a north-south line, just east of the laundress quarters. A close look at the aerial photographs taken in 1966 shows a line of small dots, which may be the privies (Photograph 5-17).

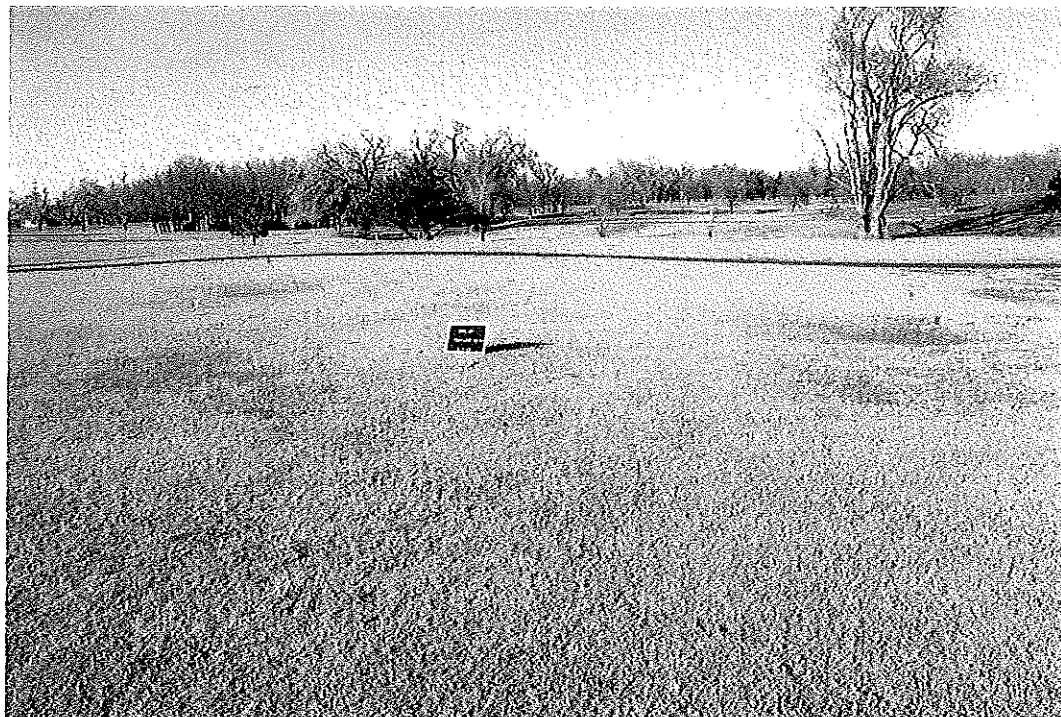
5-21

The other cluster of pit depressions was found on the level terrace along the intermittent drainage east of the fort proper, near the second cluster of dugouts, an ideal area for tent camping (Figure A-1; Photograph 5-21). Coring of these pits was limited to a small sample, as time was restricted. The three pits cored showed that they too were filled or capped with sand. The general shape of the pit depressions was somewhat irregular ovals, which is consistent with at least some of the pit toilets excavated by KSHS (Photograph 5-22).

Photograph 5-21. Overview of Possible Pit Toilets BMF89 - 95
Near eastern dugout complex
Photograph 5-22. 1966 Excavation of Pit Toilet F144
(Courtesy of the KSHS 7/28/1966)
